# Manhole Inspection Summary

Manhole # S45E\_\_028MH

Insp Date: **7/23/08 8:13 AM**

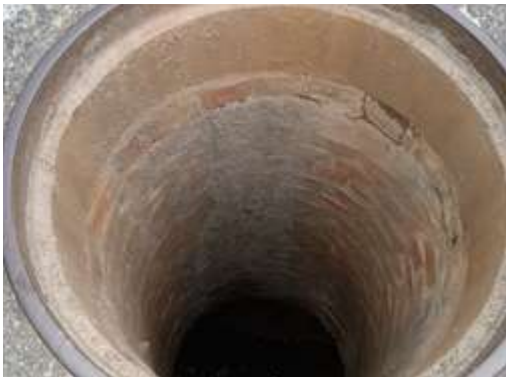
Defect 2

☒ **Leaks**

Frame Leaks

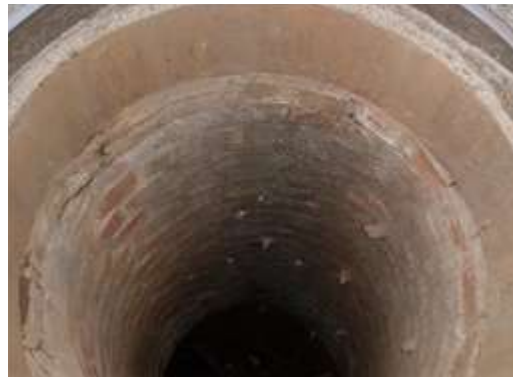
Defect 1

Infiltration: ☐ None ☐ Joint ☐ Cracks ☒ **Mortar** ☐ Roots ☐ Wall

Infiltration: ☐ None ☐ Joint ☐ Cracks ☐ Mortar ☐ Roots ☒ **Wall**

Infiltration

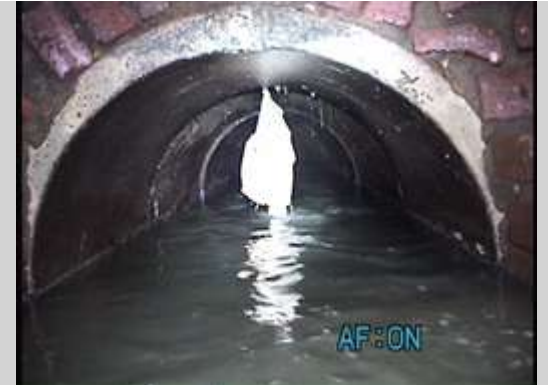
12 O'Clock Outflow

15 in. Circular Gravity Sewer  
Pipe Out @ 12 O'Clock

Pipe Height: **15.6** (in.) Rod and Bar (Angled)  
Pipe Material: **Clay** ☐ Pipe Lined  
Invert Depth: **12.50** (ft.) Flow Characteristics: **Fast**  
Deposits: ☒ None ☐ Mud ☐ Sludge ☐ Debris ☐ Grease  
Silt Depth: (in.) Deposits Extent:  
Infiltration: **None** Pipe Seal Cond: **Sound**

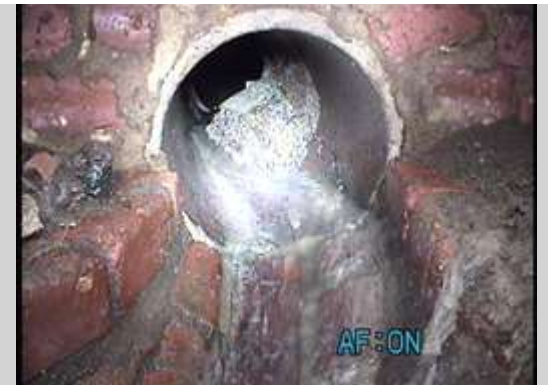
3 O'Clock Inflow

8 in. Circular Gravity Sewer  
Pipe In @ 3 O'Clock

Pipe Height: **8.4** (in.) Rod and Bar (Angled)  
Pipe Material: **Clay** ☐ Pipe Lined  
Invert Depth: **11.70** (ft.) Flow Characteristics: **Fast**  
Deposits: ☒ None ☐ Mud ☐ Sludge ☐ Debris ☐ Grease  
Silt Depth: (in.) Deposits Extent:  
Infiltration: **None** Pipe Seal Cond: **Sound**

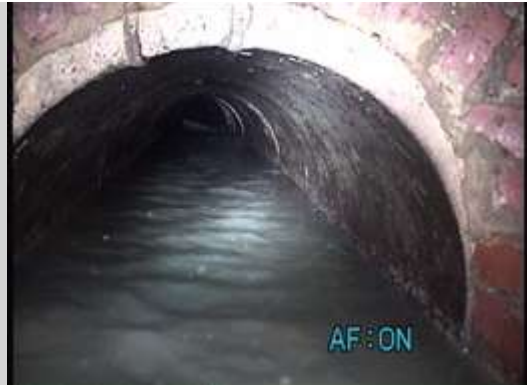
6 O'Clock Inflow

15 in. Circular Gravity Sewer  
Pipe In @ 6 O'Clock

Infiltration: **None** Pipe Seal Cond: **Sound**
